## DAM INSPECTION CHECKLIST POSSUM POINT POWER STATION POND ABC

INSPECTION DAT	E: 7/14/15	
WEATHER:	73°F, Overcast	
INSPECTED BY: D. Wat K. Honza

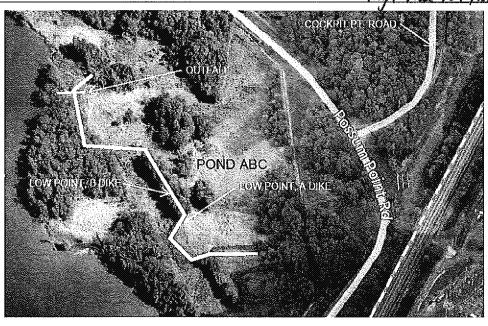
\* See figure below.

Location/ Condition	(y/n)	Change (y/n)	Comments
Low Point, A dike*			
Flow	N	Y	0855 hrs. Standing water behind sardbags and
Erosion	N	M	along princh of and small amount standing such
Low Point, B dike*			
Flow	Ν	N	0859 hrs. No Standing water behind cardboxs.
Erosion	N	N	0859 hrs. No standing water behind sandbaggs.  Rio ray and sanabays in Nace.
Outfall			
water surface El.			0902 hrs. Standing water behind sandbags and concrete weir structure. Slow seep Into veir. 23 2".
(top of stoplogs to water)			Mily Humans. 2000 reel 1410 peter. \$3.3.
